Changes

Design Changes

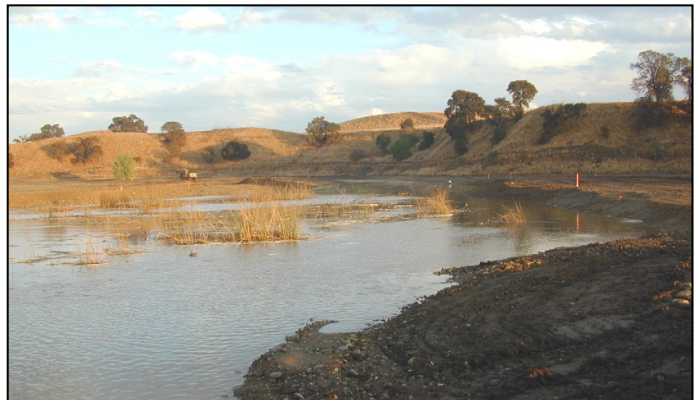
Figure 11 - Backwater Modification

At about station 79+50, the design backwater channel meets the design channel. Dimensions of approximately 400 feet of the backwater channel near its mouth were modified from the original plan (Figure 11). Engineers and biologists determined that if the portions that ran through the existing vegetated pond were maintained at the existing depth, it would increase habitat diversity and accelerate volunteer revegetation. The result is that, for that portion of the backwater channel, the depth and width are generally larger than what was designed.

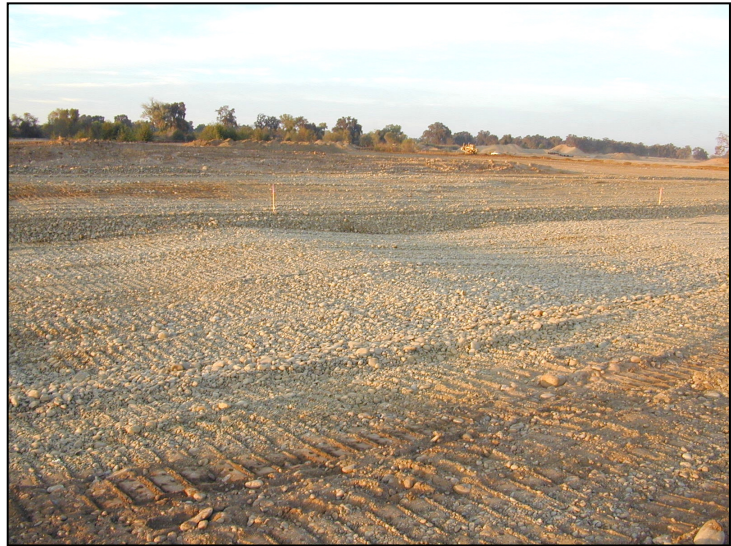
Figure 12 - Riffle Modification

One last modification to the original channel design was the addition of experimental features to several of the design riffles. This project gave designers the opportunity to scientifically evaluate spawning utilization for different riffle designs that will be monitored through a separate grant. The modifications were made to six of the twelve design riffles and varied in design only by the number of the features per riffle (see Figure 12 and Appendix C). Construction took place during the two days preceding diversion of water to the new channel.

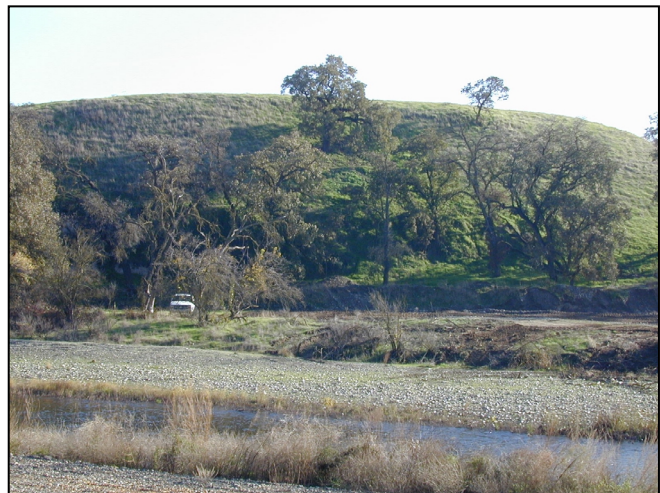
Figure 13 - Upper Construction Limit

At the upper most end of the project, the floodplain was designed to narrow on the south side until meeting the river channel at about station 4+00, but several conditions during construction required us to leave the floodplain from 4+00 to about 8+00 mostly intact (Figure 13 and Appendix A, Sheet A2). The first condition was that the final easement property line did not include the upper 200 feet of the floodplain, so work in that area would have required additional negotiation with the landowner. Second, the landowner was working on a sump in that area to supply the irrigation line, and part of the area was being used as a stockpile for the excavated material. Third, a small area with established trees had a ground elevation close to the design floodplain elevation. Leaving that area in place provided benefit to the project but had little hydraulic impact.

Once the landowner's excavations are removed, the hydraulic properties of the area should not be significantly different from the original design.

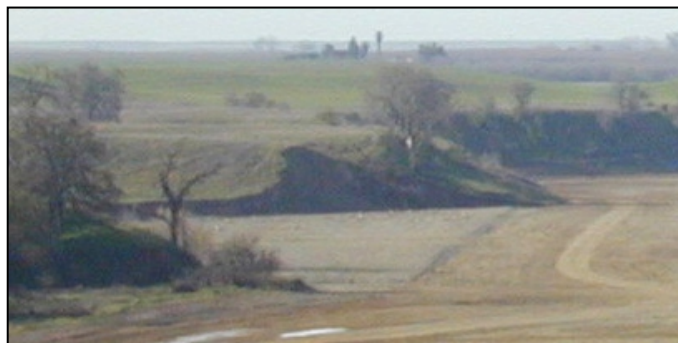
Figure 14 - Floodplain Terrace

Just downstream of the gully, engineers added a floodplain terrace feature. During construction, they determined that there might be excess material left after all fills had been completed. They designed a temporary terrace approximately two feet above floodplain grade and constructed it along the toe of the south bluff between stations 51+00 and 66+00 (Figure 14, Appendix G).

The intent was to use some of the terrace material in other areas if it became necessary later during construction, but would otherwise leave it in place permanently. The area will not significantly impact the hydraulics of the floodplain, but will allow for different types of plantings and increase diversity.

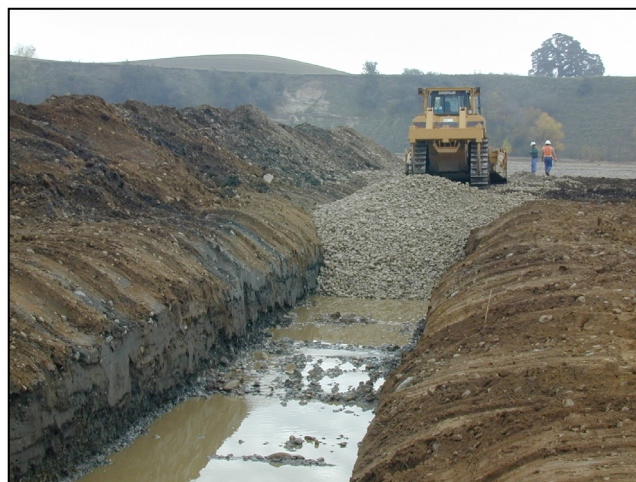
Figure 15 - French Drain Construction

The design pond was built as planned, but the nature of the material excavated from it was much more impermeable than engineers had predicted. As construction of it neared completion, it was obvious that infiltration of water from the river channel was not occurring as expected. Since this infiltration is necessary to maintain a water elevation similar to the nearby river's flow level, engineers designed and implemented a French drain (trench filled with clean gravel) from the edge of the river channel at station 86+00 to the downstream lobe of the pond (Figure 15 and Appendix A, Sheet A2). The structure was excavated through the floodplain to the elevation of the pond bottom and a width of ten feet.

One more challenge engineers faced was the unexpected lack of hydraulic connection between the constructed design pond and the design channel. Much of the sides and bottom of the pond contained a large amount of clay, which impeded groundwater flow. This presented a problem because the pond is meant to maintain a water level similar to that of the nearby reach of river. Engineers devised a solution based on the French drain concept described on page 11.

The trench was then filled with the graded material so that water will flow through it to quickly fill or partially drain the pond when river flows fluctuate. It was then covered with one to two feet of native material to encourage vegetation growth over it.

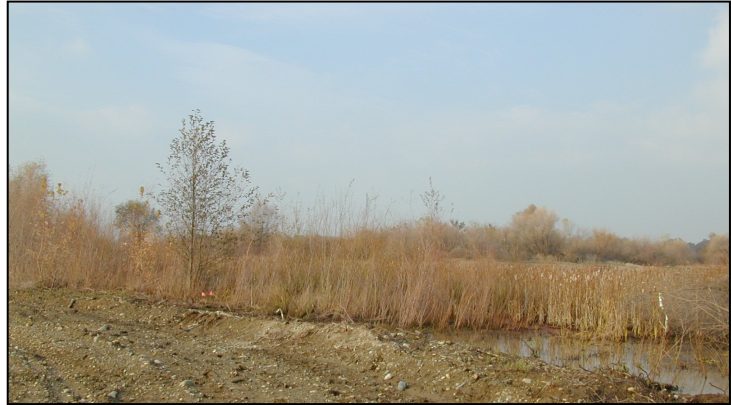
Figure 16 - Salvaged Wetland

The Simulated Abandoned Channel (SAC) that was designed to stretch from station 60+00 to 94+00, surrounding the pond, was slightly altered. The original plan called for it to completely surround the pond and its islands including the area between the pond and haul road. Although most of the area was constructed as designed, engineers determined that a large portion of the existing wetlands between the downstream island and the haul

road was at an elevation similar to the design elevation. Since the existing habitat was more valuable than what could be constructed and revegetated, it was kept as it was and construction worked around it (Figure 16, Appendix D). The arm of the SAC that was to lead downstream from the pond was also not constructed for two reasons: first, it was determined that much of the water maintaining the salvaged wetlands would likely drain out via the SAC; and second, the end of it would have traveled through two rows of mature trees that we preferred to leave in place.

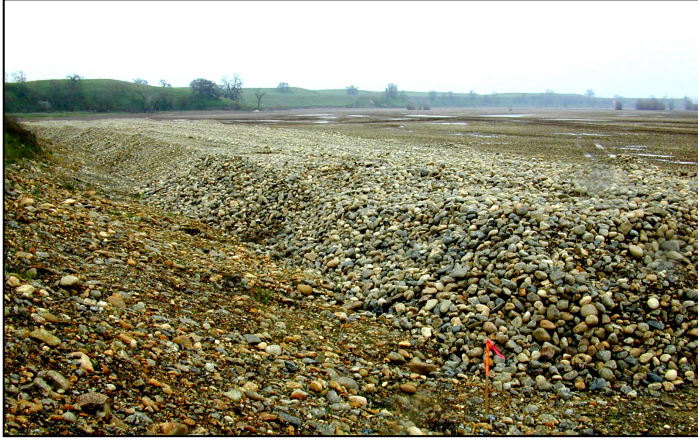
Figure 17 - Graded Material Stockpile

The constructed channel required less than the estimated 60,000 cubic yards of graded material to complete, so the stockpile was moved to an on-site storage area. The

material will be used in the channel for future gravel augmentation work. Approximately 8,000 cubic yards of the material was placed in a stockpile 50 to 100 feet wide and five to six feet tall (Figure 17). It is located on the south floodplain at the toe of the bluff between stations 38+00 and 44+00 (Appendix A, Sheet A2).

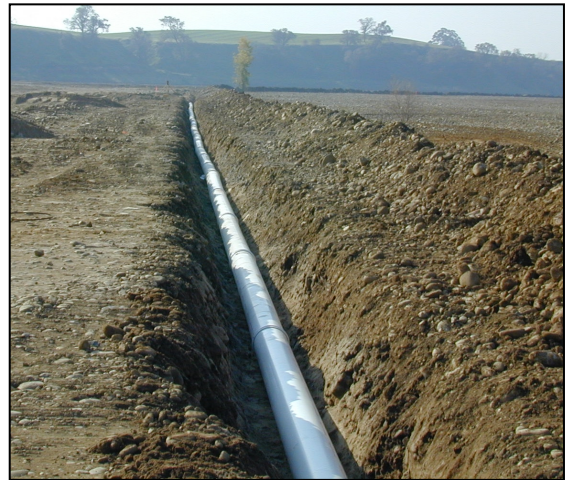
Figure 18 - Pipeline

During design for the revegetation of the project, designers determined that irrigation would be necessary for the south floodplain upstream of the backwater. Originally it was intended that the supply pipeline would be installed in the early spring after project construction was completed, but it was later determined that irrigation would be necessary in early spring, which meant the pipeline would have to be operational by the end of construction. Planners decided to take advantage of the current construction contract to install the line. It extends from a pump near the river at station 10+00, across the farmed terrace south of the floodplain, and runs directly through the south floodplain from stations 46+00 to 78+00 (Figure 18, Appendix E). The line will accommodate both flood and drip irrigation of the plantings.

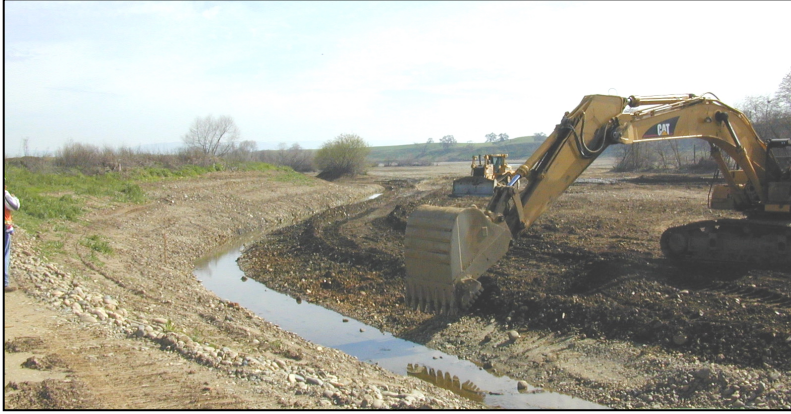
Figure 19 - Ditch and Narrow SAC

At the end of construction the contractor determined that there was not enough material left on the north side floodplain to complete it to specifications. Since the bridges across the channel had been removed, the excess stored on the south side was not readily accessible to them. To help the contractor complete the floodplain construction in a timely manner, engineers added a short, narrow section of shallow channel (similar to a SAC but draining upstream to the pond rather than downstream) to follow part of

the drainage ditch between the culvert and pond (Figure 19 and Appendix A, Sheet A2). Construction of this feature provided enough material for other areas of the floodplain that required additional fill. Since the lower arm of the SAC around the pond was not constructed, this addition did not increase the overall area of SAC on the project site.

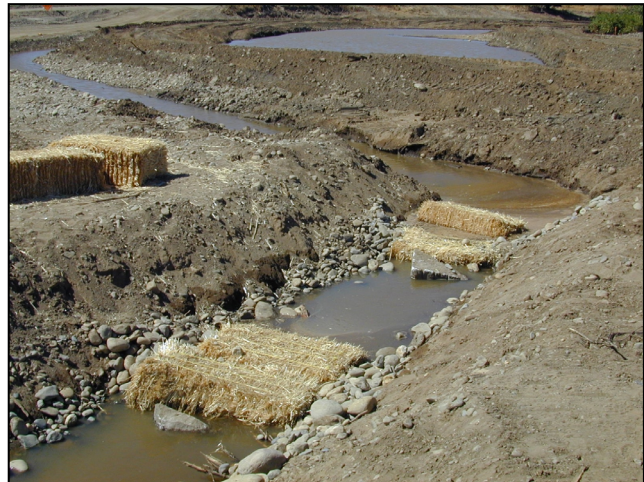
Figure 20 – Dewatering and Settling System

Another problem that was encountered during construction was the excessive seepage of farm irrigation water onto the north floodplain and into channel excavations. The problem was worst during seasonal irrigation of the adjacent alfalfa fields, but was an issue throughout the duration of construction. A complex system of settlement ponds and drainage ditches were used to dewater the area downstream of station 90+00 because the water picked up silt in the work area and could not be allowed to drain to the river before it settled out (Figure 20). Upstream of station 73+00, the contractor maintained a long ditch between the haul road and the constructed floodplain, which drained water to the design pond so that it would not spill out onto the floodplain. These actions were in response to this unforeseen challenge and took time to develop during construction, but they were ultimately effective in aiding the contractor to complete the work required.

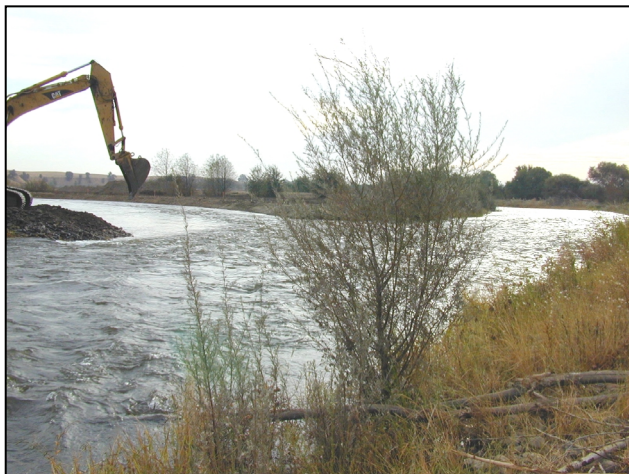
Figure 21 - Split Flow

Diversion of the river flow from the existing channel to the newly constructed design channel also proved to be a significant challenge. Most of the design channel was constructed in relatively dry conditions while the river bypassed it until channel construction was complete. As sections were completed, the water was diverted to the new channel, but careful consideration was given to the process by the contractor and

inspectors to ensure that all permit requirements were complied with. The flow was slowly increased to the new channel while maintaining flow in the old channel resulting in a split flow between the two (Figure 21). That flow was then maintained for at least 24 hours before the former channel was closed off at the downstream end. This was to ensure that flow downstream was not cut off for any period of time, and water in the former channel was never drained. As each section of former channel was closed off at the lower end, some inflow was necessary, as well as relief ditches

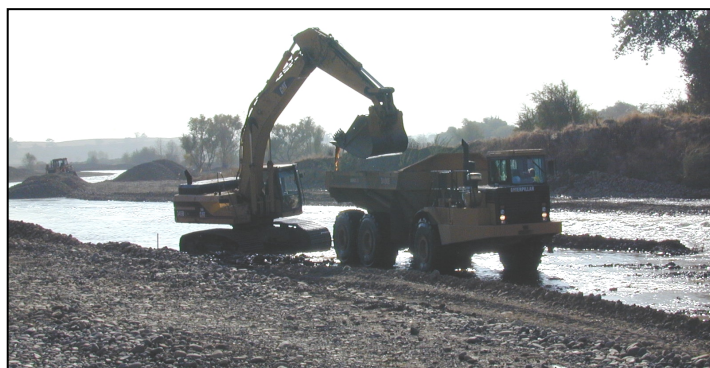
Figure 22 - High Water Work

Toward the end of channel construction, we faced the challenge of higher flows. Flows were increased from about 200 cfs to around 700 cfs for the last two weeks of October, just before work began on the portion of the channel which could not be bypassed. As a result, the contractor had to configure the design channel in water up to six feet deep (Figure 22). They were forced to modify their construction procedures, and inspectors also had more difficulty checking grade of the channel due to the swift water. To ensure the channel's completion before October 31st, the Department issued an acceleration order to the contractor.

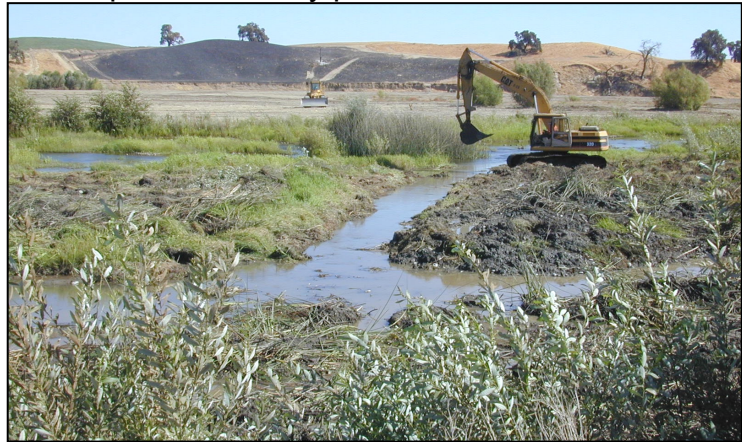
Figure 23 – Excavator used for Wetlands

One of the highest priorities of Department inspectors during the construction of this project was to comply with permit requirements (see Appendix H for partial list of requirements). All special status species, as well as common fish and wildlife species, were handled with care throughout construction. At the beginning, nesting Swainson's Hawks in a tree near the project boundary meant machinery had to be kept out of a large portion of the upstream end of the project until hatchlings fledged. The contractor also had to stay out of a potential woodrat nesting site until biologists were able to determine whether or not the animals were present. Every person who came to work on the project had to first go through training so that they knew what to look out for and what to avoid. This training was offered as frequent tailgate meetings held by Department environmental scientists. During filling of the wetland areas, biological monitors worked closely with the operators, and the contractor was forced to fill at a steady pace to allow wildlife to exit ahead of the equipment. The Department paid for an extra excavator used to create exit channels through the wetland grasses during this process (Figure 23). While the former channels were being filled, water continued to flow through them and out relief channels so that they would not dry out and fish could escape.
